Re: 190513 Harbach - Testing of Lifting Lugs PO HBRM-0364

Pursuant to your purchase order number HBRM-0364, we have completed the testing on the submitted lifting lugs. The results of our analysis follow.

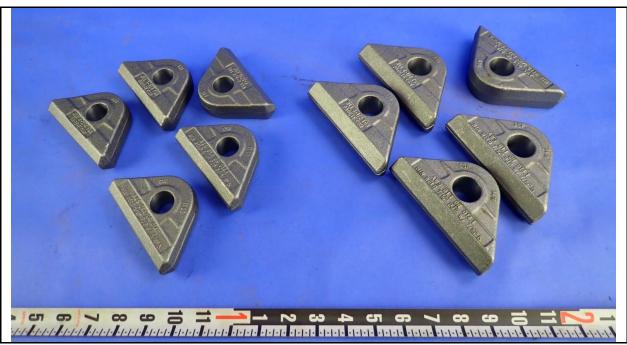
Figure 1
The as-received test samples are shown above. Group A (4-3/4 Ton) is at left, and group B (6-1/2 Ton) at right.

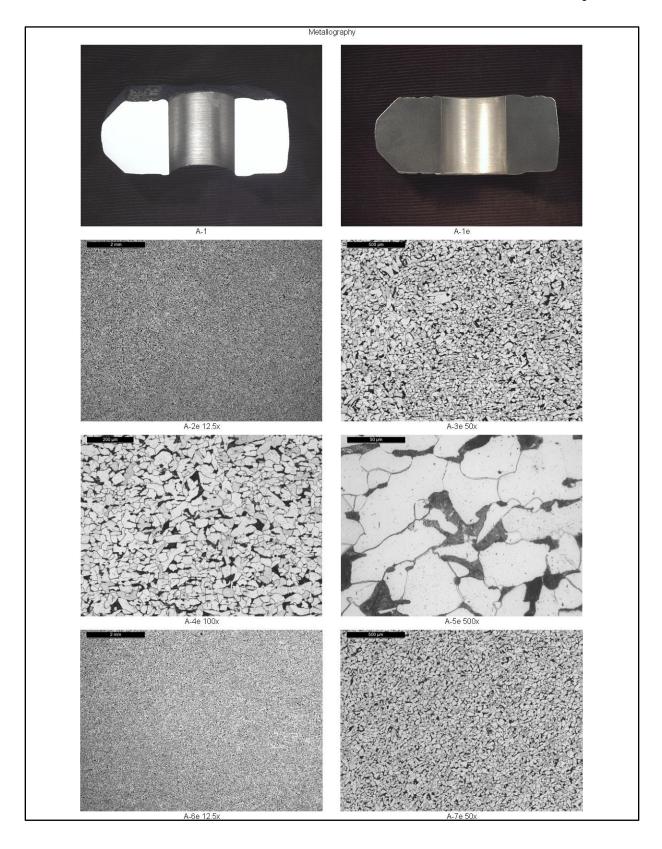
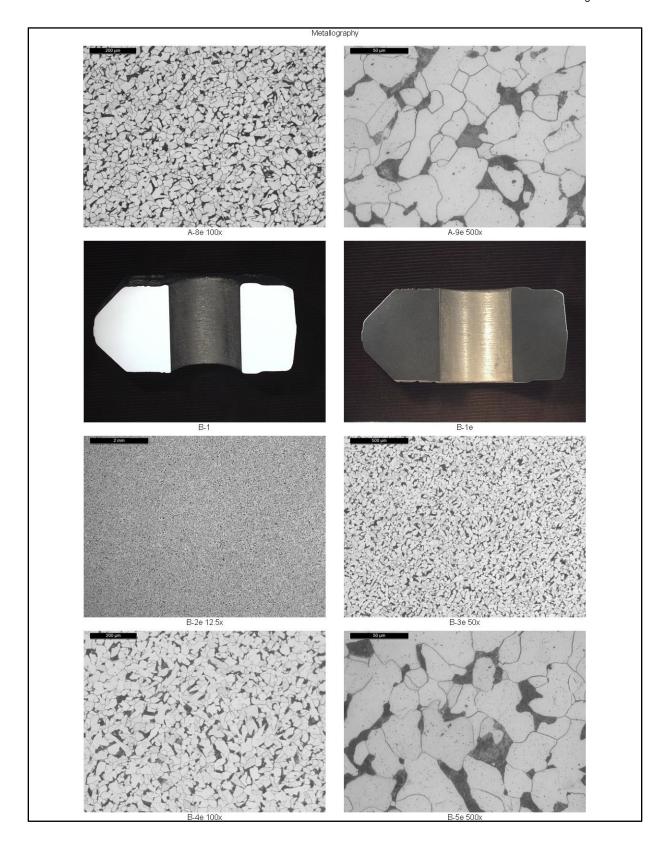
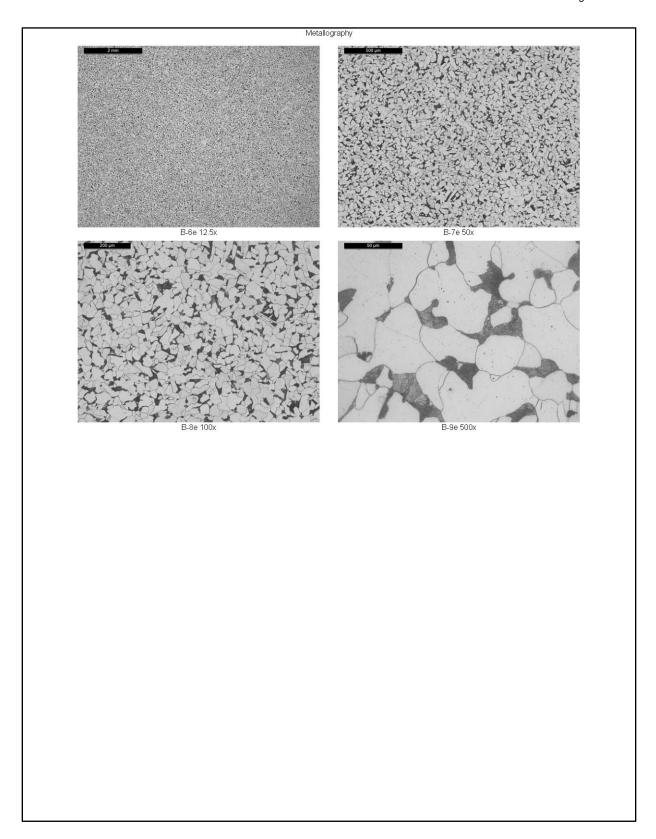
APPENDIX A Metallography

- 1. One lug from each group was sectioned through the center to evaluate the forging macro and mico-structures. Examination of the cross sections in the as polished and etched conditions showed no excessive material flow and no edge cracking. The microstructure was composed of fine grained, equiaxed ferrite with some pearlite typical of a low to medium carbon steel.
- 2. Images of the microstructure are attached in appendix A.

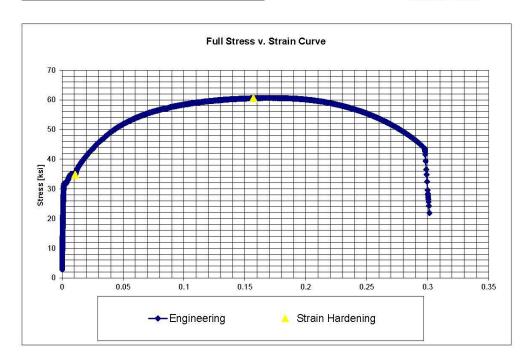
#### Tensile Strength Determination per ASTM E8

0.2597888
 117.868803
 0.000296616

K: 2.75336E+46 n: 16.57109593 α: 1.846562292

E [Mpsi] 29.383

3. A round, sub-size tensile specimen was removed from each group and tested per ASTM E8. The results are summarized as follows:

Specimen	Tube	0.2% offset Yield Strength [Ksi]	Tensile Strength [Ksi]	Elongation in 1"	Reduction of Area [%]
124-A	A	31.8	60.6	61.6	66.1
124-B	В	39.1	61.9	29.0	64.8

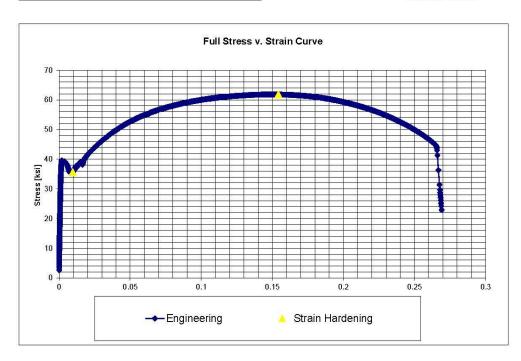
Specimen: 513-B

# Tensile Strength Determination per ASTM E8 Ultimate

0.2684033
 123.295294
 0.000344583

K: 1.1892E+66 n: 23.91084671 α: 1.50420604

E [Mpsi] 29.432
